Breakage of the tip of the cannula in the adipose tissue during liposuction

During liposuction, 3 cm of the distal segment of the cannula broke within the patient's adipose tissue. We used an image intensifier to easily and quickly address this complication without the development of any sequelae for the patient.

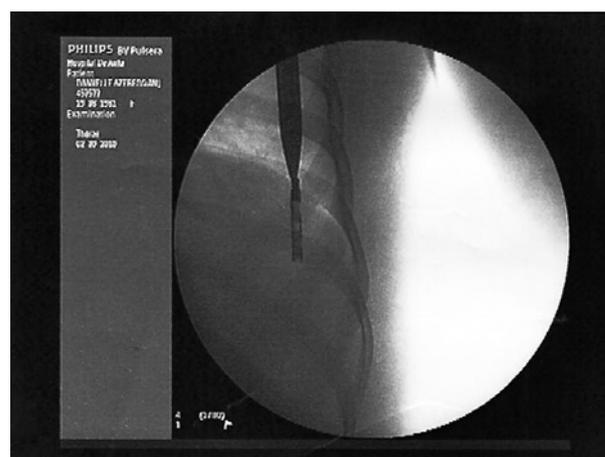
the procedure performed in the area examined, via a video screen and in real time. By using this equipment and with the aid of an Allis forceps inserted into the original liposuction incision, the tip of the cannula was “retrieved and removed from the adipose tissue (Figures 2 and 3).

Figure 2 – A straight hemostatic forceps reaches the broken segment of the cannula.

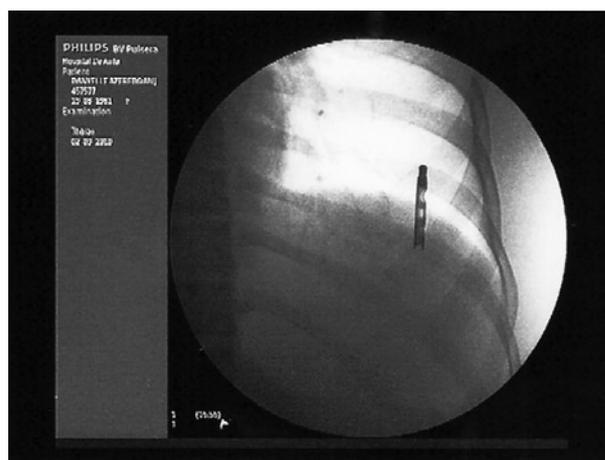
Figure 3 – Profile view of the broken segment of the cannula against the ribs.

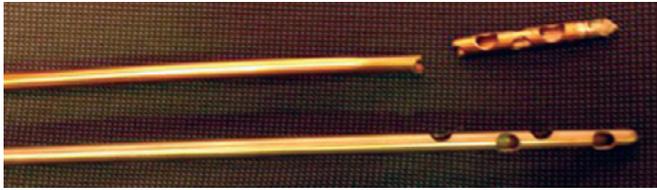
Cannulae for aspirating subcutaneous adipose tissue are available in several materials, diameters, and lengths, and with different types of tips and orifices. The instrument used in this procedure was a steel cannula, 25 cm long, with a diameter of 4 mm and 5 orifices of 1.5 mm × 2 mm each (Figures 4 and 5). Cannulae similar to that used in this study have been employed by the surgical team for more than 5 years without any inconvenience. This particular cannula had been used for only 3 months and had not shown any sign of deterioration.

The cannula described in this study probably had defects, as narrow openings in the form of “slots”, in the region of the lumen that, because they were in the interior of the cannula, were not detected by either the manufacturer’s quality control evaluation or the medical team. This case demonstrates that, even with experienced surgeons using materials in perfect condition, unexpected situations might occur. Many professionals rely more on their personal experiences in troubleshooting than on scientific articles, often because of the lack of studies discussing these complications. No case reports similar to this study were found in the literature.

Figure 5 – Broken tip of the cannula, 3 cm in length.
