Increase in the volume of the breast implant by passing organic material into it

MILTON JAIME BORTOLUZZI DANIEL¹

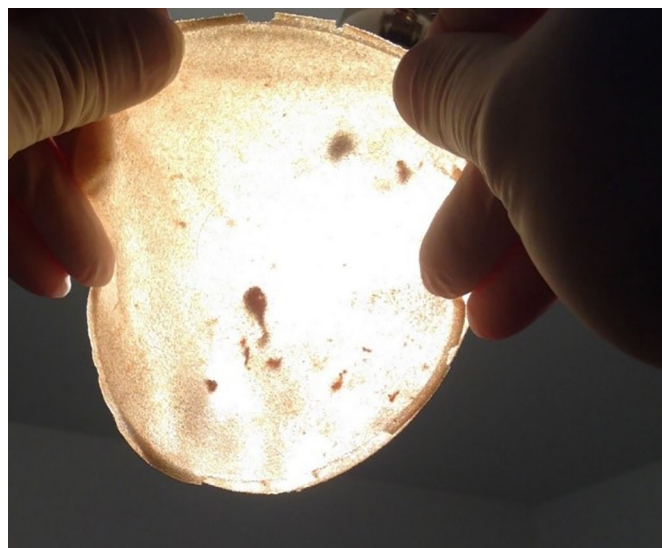
Figure 1. First implant found more than 20 years ago with a substance inside.

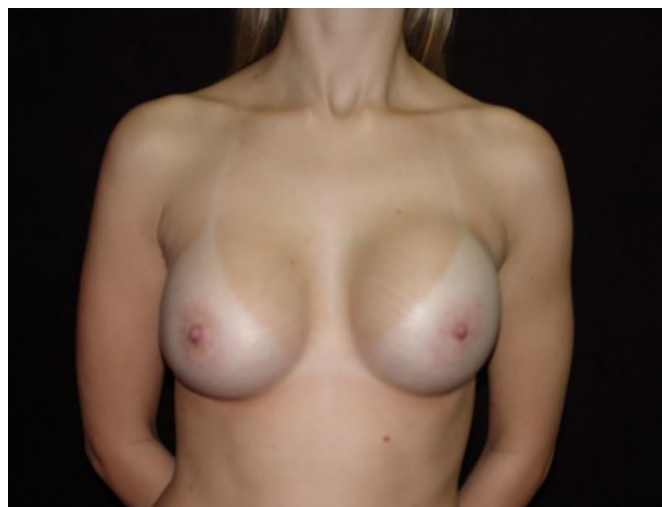
Figure 2. Patient with enlargement of the left breast after 3 years of implantation.

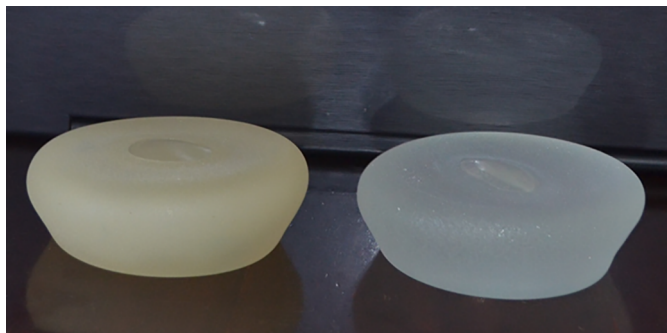
Figure 3. Pair of textured submuscular implants, explanted after 3 years of use. It can be seen on the left showing a yellowish color and an increase of 30ml. Whenever the implant changes its original color, there is fat inside it.

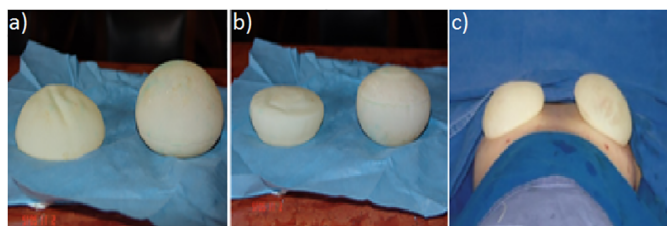
Figure 4. A: Original prosthesis 255cc polyurethane and 300cc with volume increase by substances inside. **B:** Same inverted prostheses. **C:** Transoperative explantation.

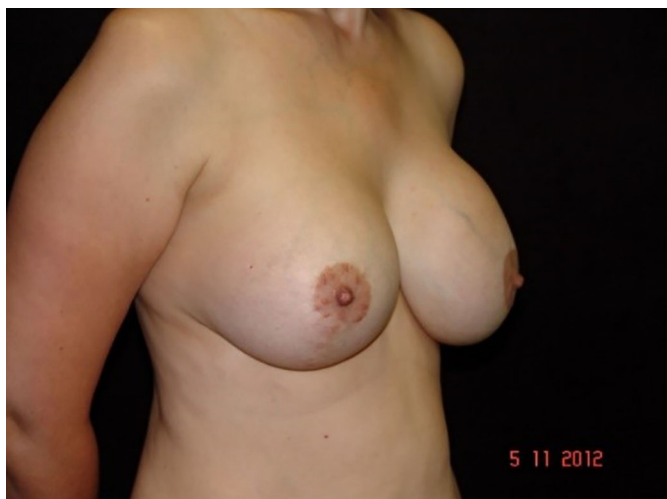
Figure 5. Patient with increased volume in the left breast after 8 years of implantation. Two pregnancies in the period.

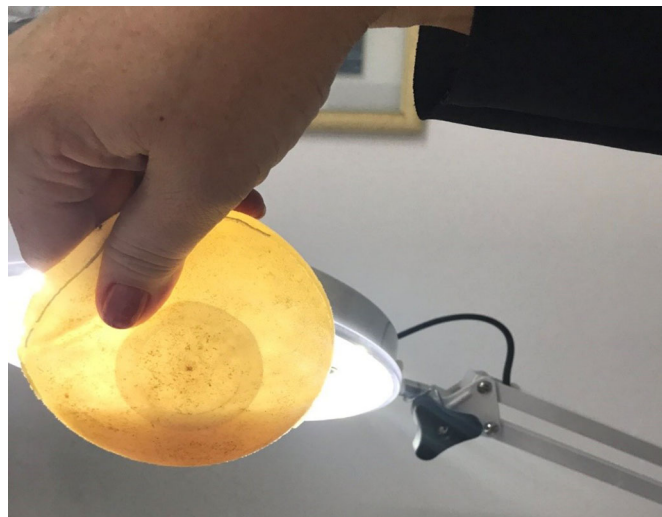
Figure 6. Silimed® implant 215cc polyurethane. By transillumination, the substance is observed inside the prosthesis.

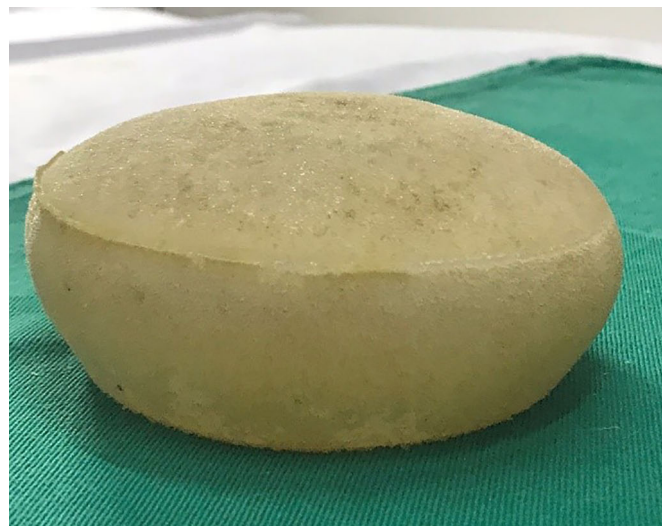
Figure 7. Silimed® implant 215cc polyurethane. Increased to 300cc after 8 years of use.

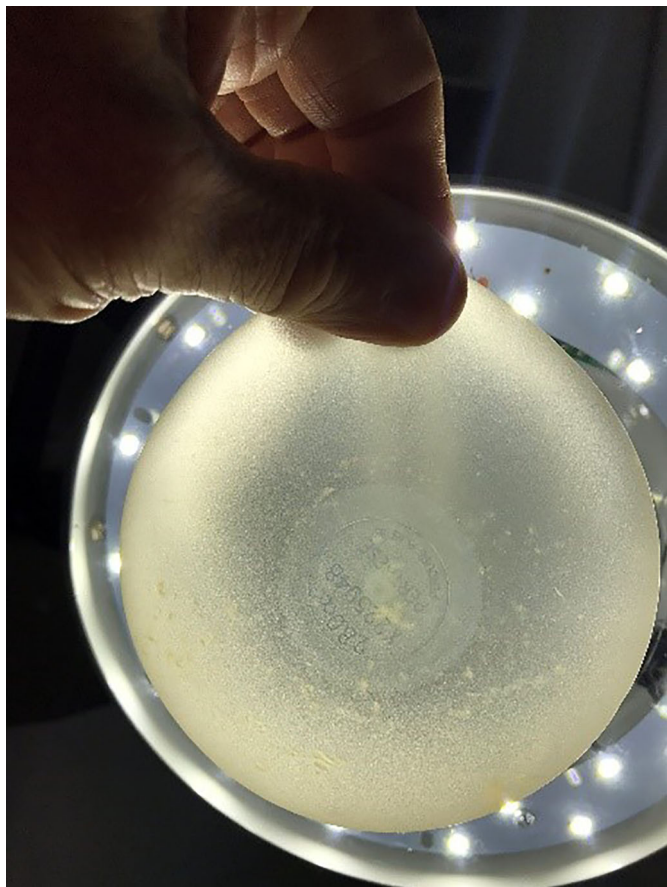
Figure 8. Menthor 225cc implant, 5 years old, in transillumination.

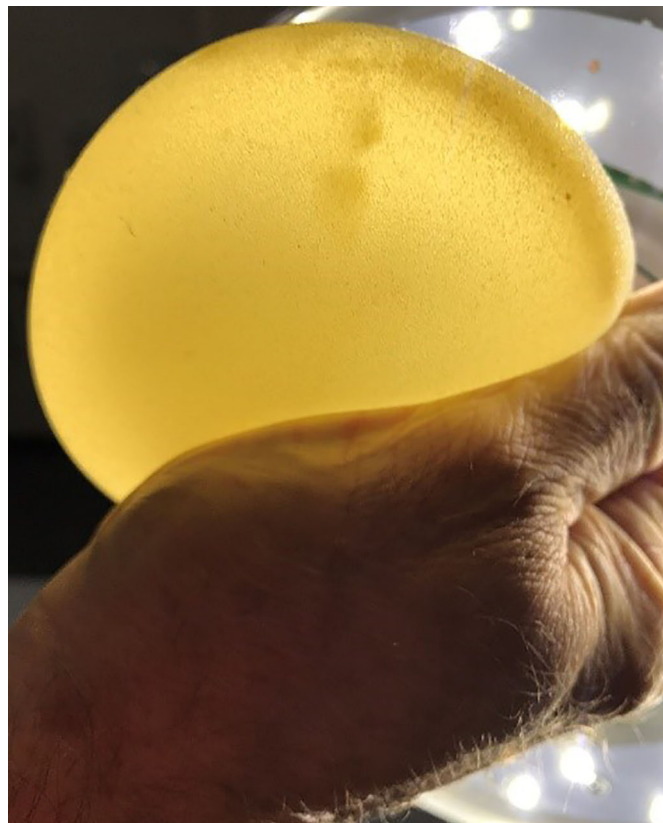
Figure 9. 280cc Pherthese implant showing heterogeneity inside.

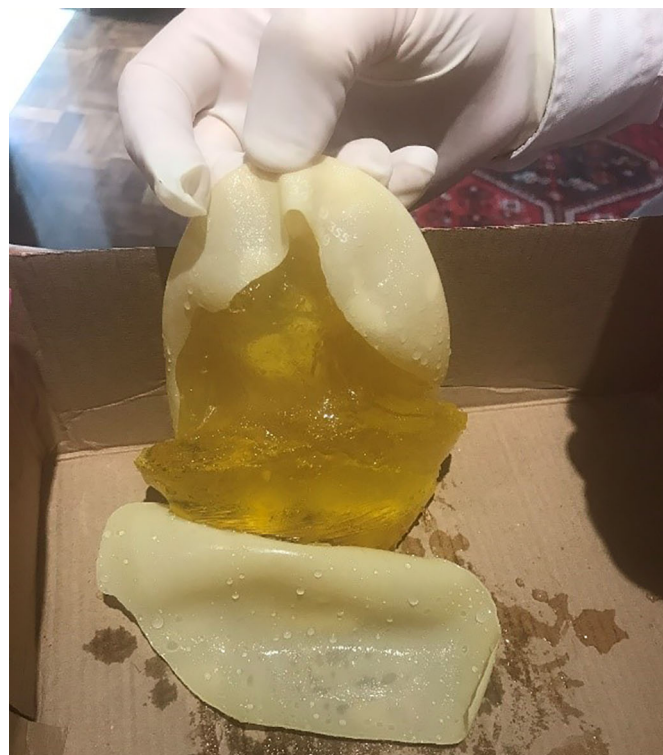
Figure 10. Silimed® 355cc implant, removed after 4 years of use.
