Breakage of the tip of the cannula in the adipose tissue during liposuction

During liposuction, 3 cm of the distal segment of the cannula broke within the patient's adipose tissue. We used an image intensifier to easily and quickly address this complication without the development of any sequelae for the patient.

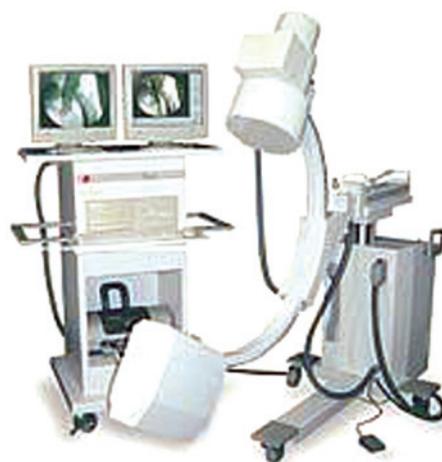
Subsequently, the use of an image intensifier was considered (Figure 1). The device installed in the surgical unit is used by several specialties including urology, neurology, and, in particular, trauma surgery. This instrument provides live radiography, thus facilitating the monitoring of

Figure 1 – Image intensifier.
